# **BLAST SHIELDS TESTING**

by Walter V. Medenica

George C. Marshall Space Flight Center

NASA TN D-4894

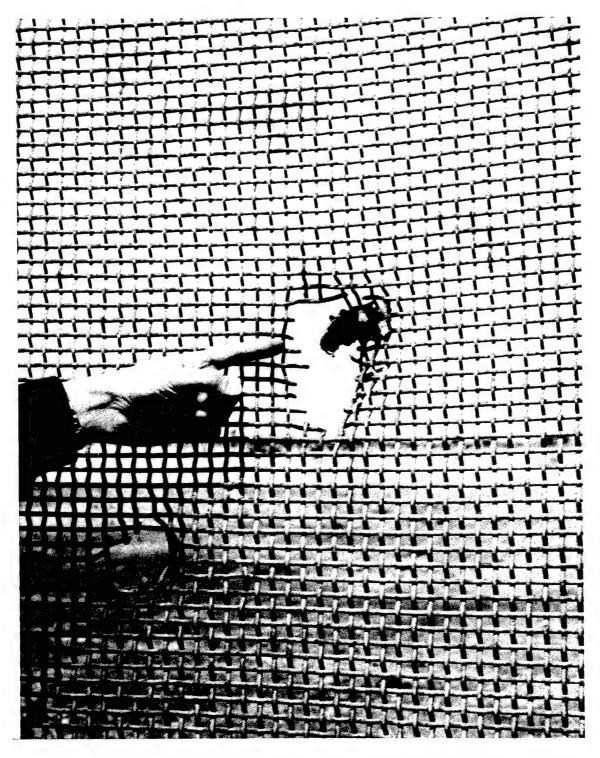
FIGURE 22. SHRAPNEL PERFORATION OF WIRE SCREEN, TEST 301

The relative effectiveness of wire screens with less than 50 percent open area is not clear. Here again, a few more tests would give the answer. For the time being the only actual benefit one could expect from wire screens is a certain protection from light flying fragments. The tested wire screens which survived the blast well still were perforated by flying fragments (Fig. 22).

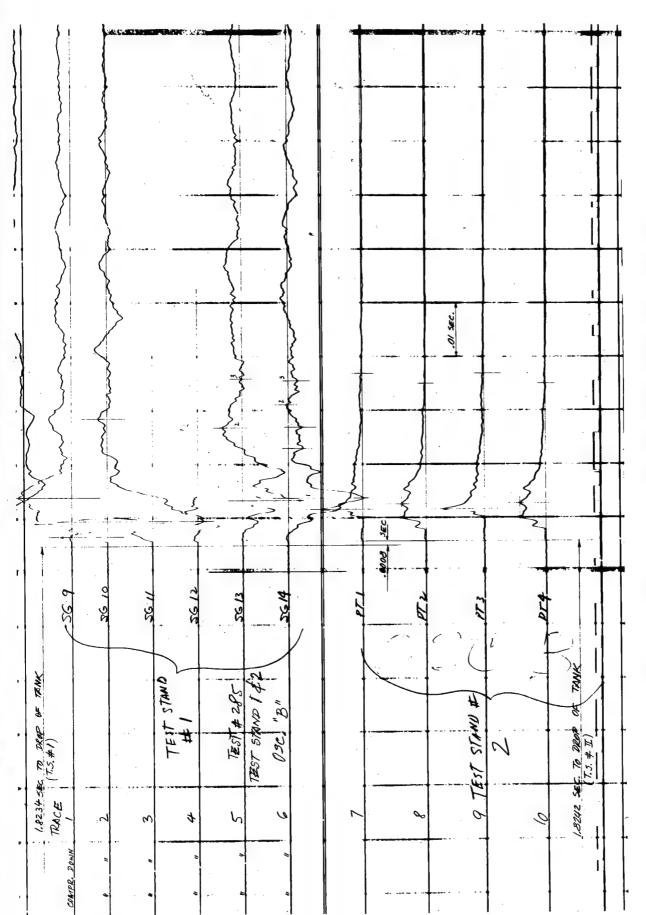
FIGURE 24. SAMPLE OF RECORDER OSCILLOGRAPHS, TEST 285

This structural evaluation is based on recorded strains at the first highest peak of the same sign (tension or compression). As Figure 24 shows, the first highest peak of the same sign is usually the highest of all. This, of course, is to be expected, except in cases where the material under the strain gauge goes into the plastic region, as was the case with strain gauges SG-11 and 12 on Figure 24.

It will be noted on Figure 24 that traces of pressure transducers PT-2 and PT-4 indicate two peaks of practically equal magnitude, one immediately before and one immediately after PT-1 and PT-3 reached their peaks. The first peak on PT-2 and PT-4 is the reflected overpressure from the blast shield and the supporting structure; the second peak is the reflected overpressure from the GSE consoles (Fig. 19).

Traces of strain gauges SG-1 and SG-2 on the arched plates (Fig. 19) do not show only tension, as one might expect, but a succession of tension and compression. The reason for this is the arched depth of the plate (approximately 12 in.). The shock front and the reflected overpressure, from the front and from the back, reached different parts of the arched plates at different times, causing bending moments in the plate with consequent alternating stresses.

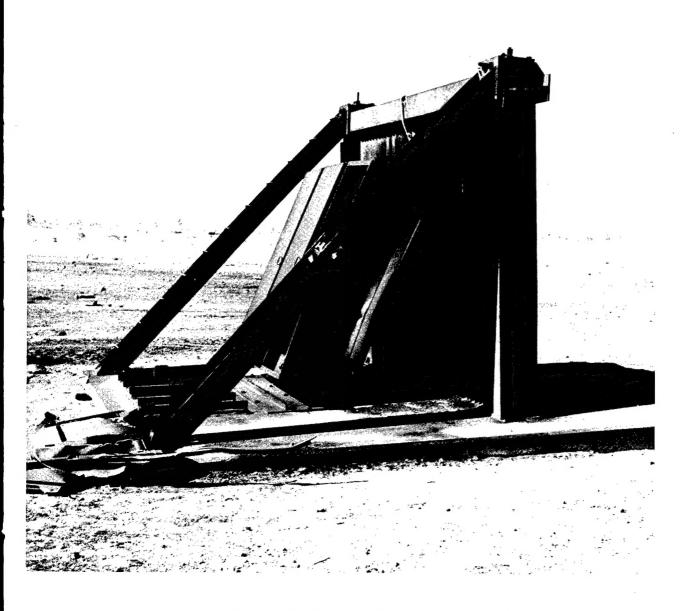
FIGURE A-13. TEST STAND NO. 1 AFTER EXPLOSION, TEST 301 (BLAST SHIELD: ANGLE DEFLECTOR)

This Titan I test (Fig. A-12) of low explosive yield caused slight damage to Wire Screen No. 2, and no damage to the angle deflector (Figs. A-13 and A-14). Some holes were perforated in the wire screen by flying fragments, and some bottom wires were ripped loose from their welded connections. Here again the failure occurred at the most rigid location of the blast shield as was the case with arched and flat plates.

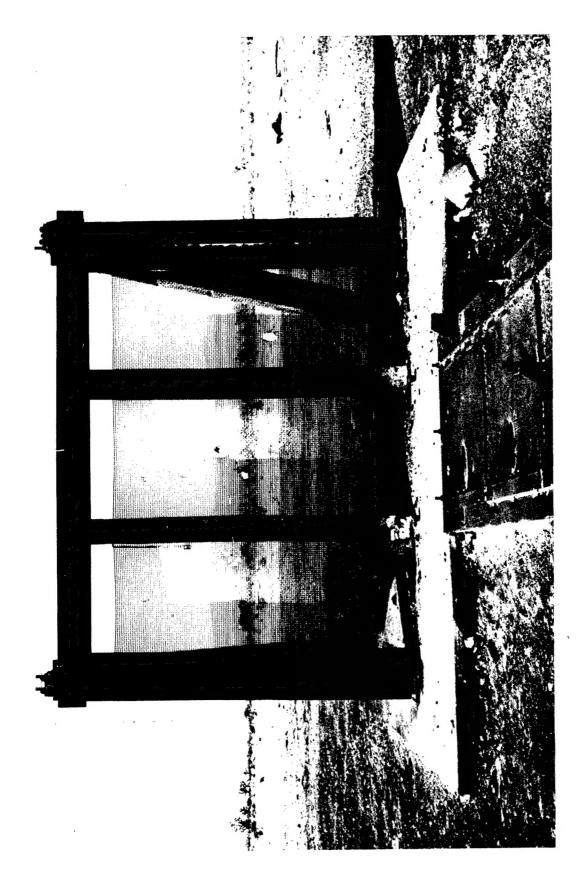
FIGURE A-14. TEST STAND NO. 2 AFTER EXPLOSION, TEST 301 (BLAST SHIELD: WIRE SCREEN NO. 2 WITH 48.0% OPEN AREA)

The same, damaged, GSE cabinets from Test 300 were exposed to blast again in this test. The shedding vortices of the overpressure wave around the blast shield, and the momentary higher overpressure behind the cabinets, pushed the cabinets against the blast shield. It is surprising that they were overturned now, and not during the stronger blast of Test 300. The reason for this is the weakening of anchorage during Test 300, so that relatively small overpressure was sufficient to overturn them during Test 301.
